SAYBROOK GATES

The art of the craft

Renovation and Refurbishment

2012

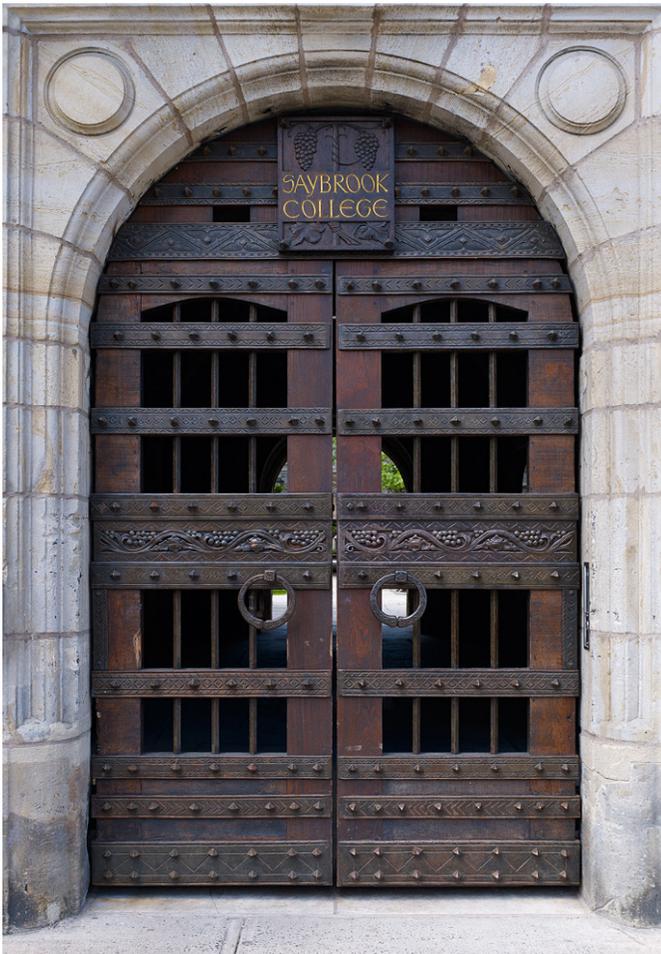
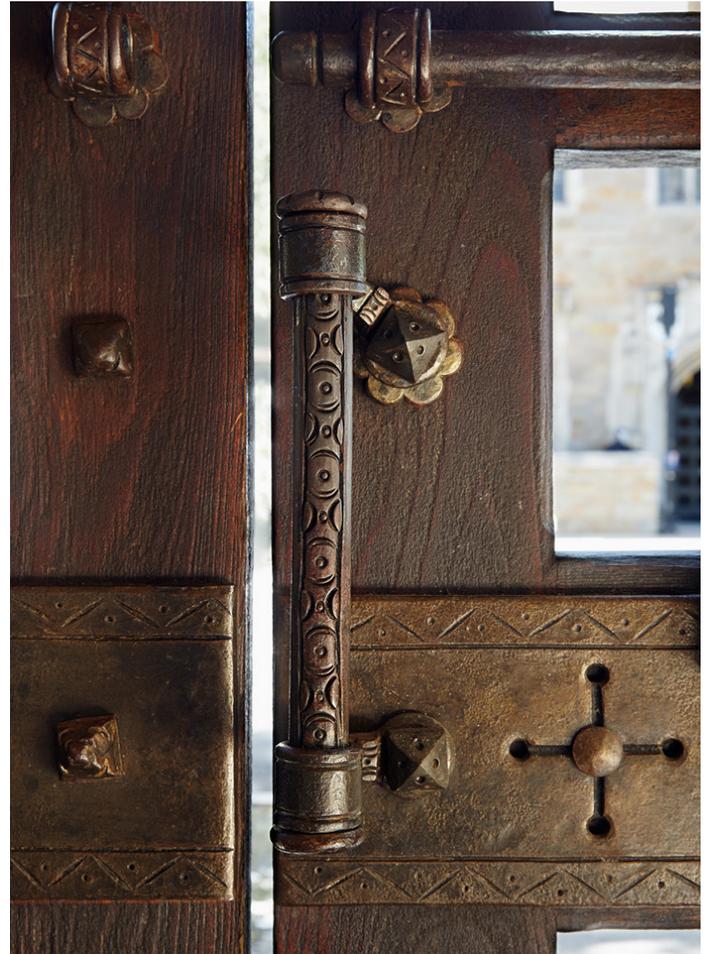
Saybrook Gates today are a portal between student housing and academic buildings. After decades of daily use and multiple repairs of varying quality, the gates and their hardware were in poor condition.

The teak gate frames were originally finished in a hand-adzed texture that imparted a subtle rippled effect to the surface. This texture had been obscured in the prior sand/paint cycles, but patches still remain evident. The metal is "Swedes Iron" a type of highly refined wrought iron preferred at that time for ornamental work.

Restoring the work of a master is a patient, painstaking business. With the goal of restoring the gates' aesthetic distinction and modernizing its function for lasting success, CWA worked closely with Hammersmith Studios to uncover, diagnose, treat and finish the gates.

The quality of the finished work speaks volumes to the talents of the craft-workers involved. Repairs in the metal work are indistinguishable from the original work in terms of technique and texture. Wood repairs are neat and honest and sit comfortably with the hand worn edges. A non-film-forming finish that can be refreshed with a minimum of effort, and most importantly, no sanding, ensures excellent maintenance over time.

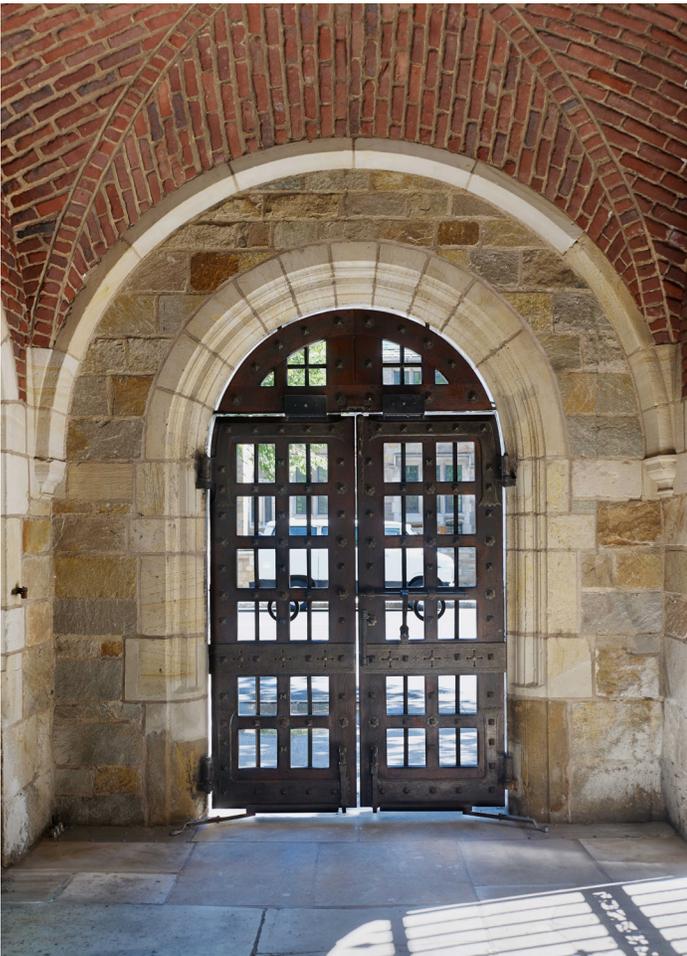
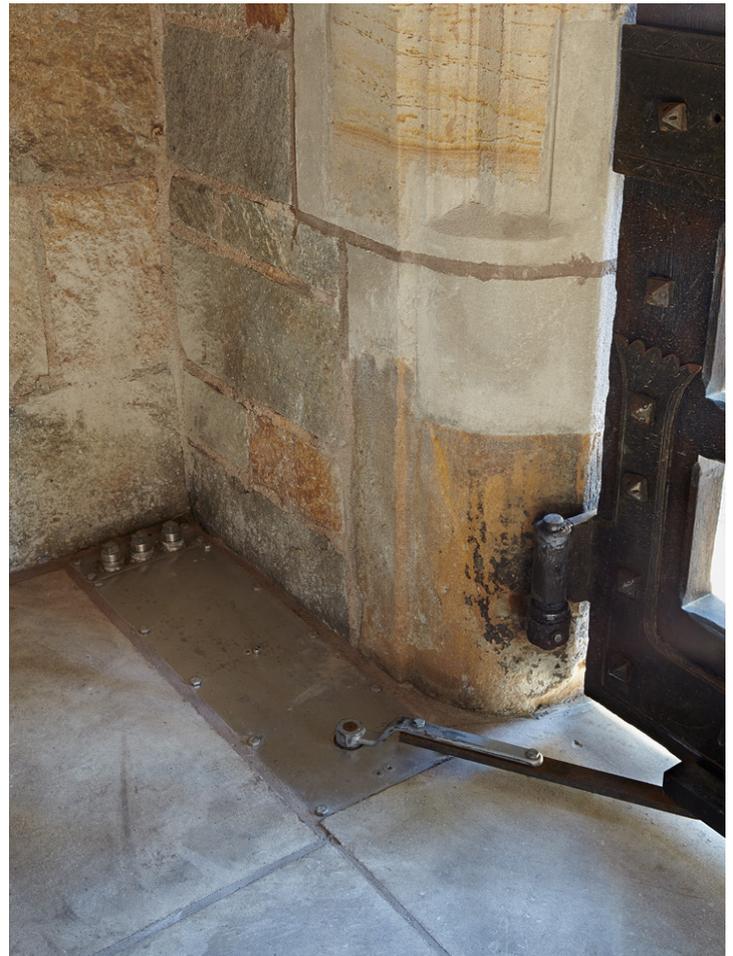
Repairs and operating mechanisms. Restoration, repairs and modern additions are indistinguishable from the original work in terms of technique and texture.
